Metal Edge Flashing

Why is Metal Edge Flashing Important?

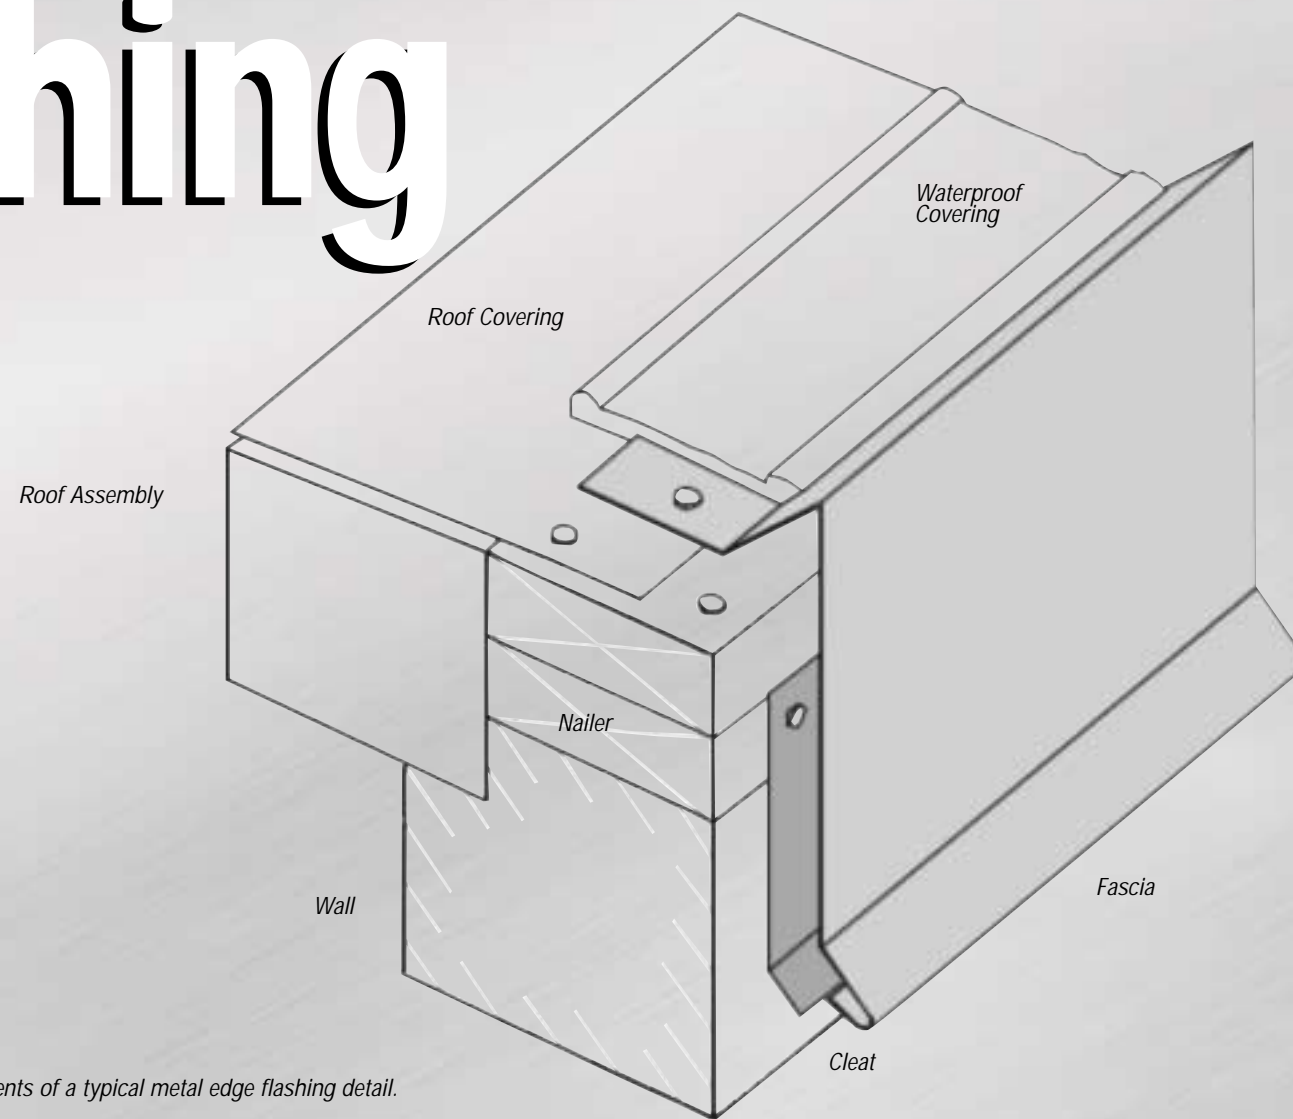
Components of a typical metal edge flashing detail.

Nailing substrates, or nailers, provide a means for connecting metal edge flashing to the building structure. As shown in the illustration, typical nailers consist of two pieces of lumber. Anchor bolts hold the lower piece to the wall or roof framing

system. Nails then hold the upper piece in place. Under design of the anchor bolts or nails between layers can cause the entire assembly to lift out of place, allowing wind and water to make their way underneath the roof covering and inside the walls.

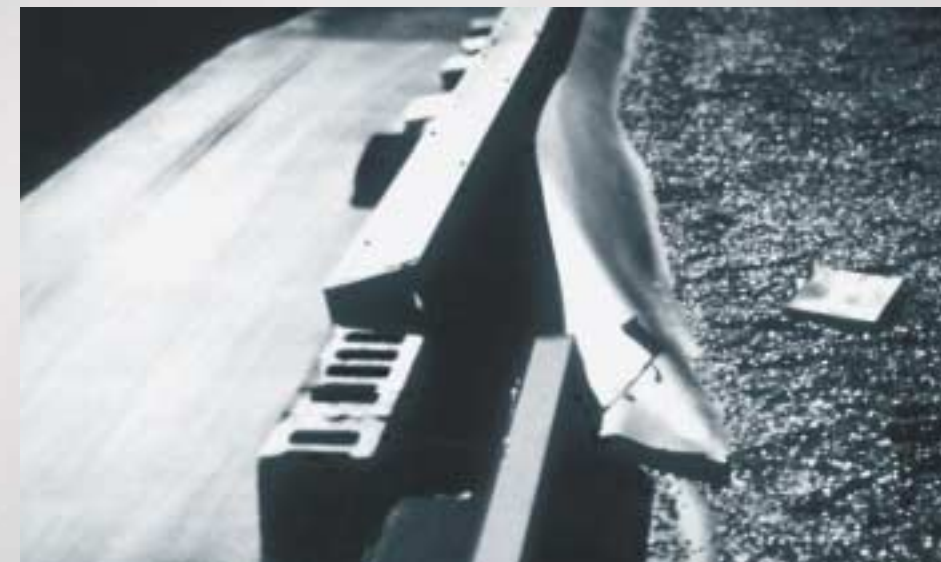
Failure of nail attachment to masonry wall.

All nailers, even those adequately designed for uplift loads, are vulnerable to deterioration over time. Water penetration can cause the wood to rot and fasteners to rust, diminishing the capacity of the connection of the flashing to the nailer as well as anchorage of the nailer back to the structure.

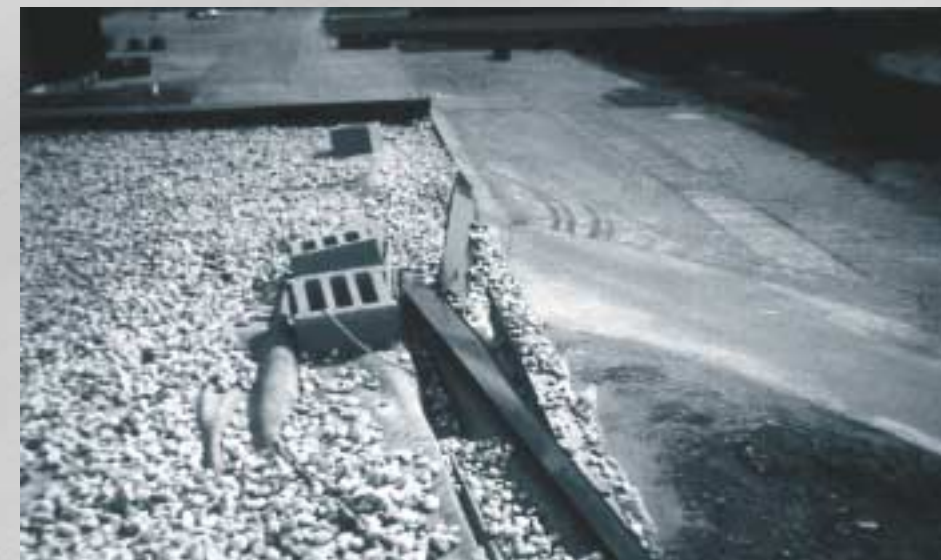
Bent and peeled flashing creates gaps for wind and water penetration

Metal edge flashing failure usually begins with the fascia. Outward wind pressures cause it to pull away from the building and bend upward. Once the fascia is bent like this, the wind has a lot more surface area to push and pull up on, causing the entire assembly to peel away from the building. At this point, it can pull the roof covering with it or it can tear off of the building entirely, becoming a wind-borne missile.

Two conditions cause the fascia to bend: the failure of the fascia's lower restraint and the lack of bending resistance in the flashing material. Metal edge flashing systems are frequently designed with a hook strip, or cleat, which holds down the bottom of the fascia. If this is missing or inadequate, the flashing material itself

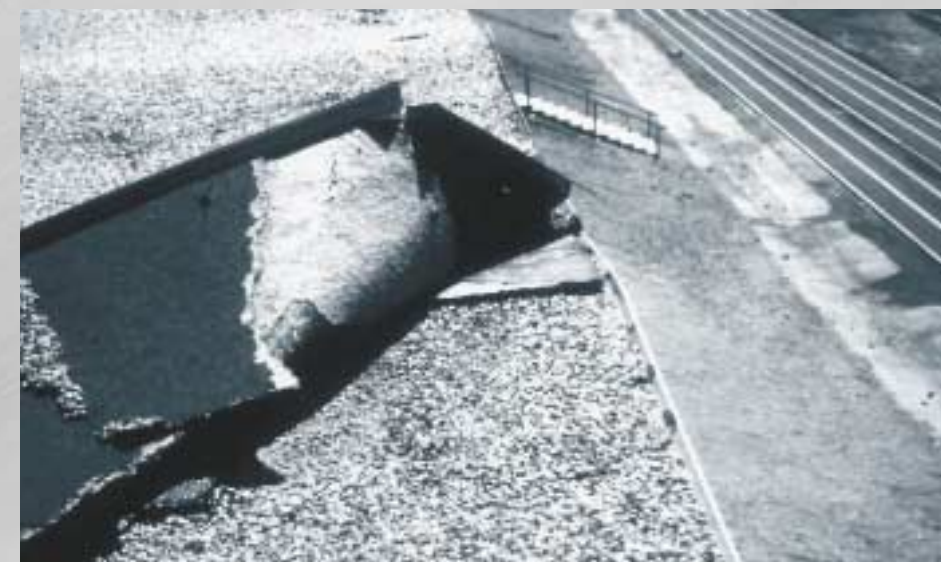
Bending and peeling of flashing takes the top layer of roof covering with it.
